## Observations on transports of "breeding" cattle to Russia: Observations from 16.02. to 21.02.2007

Team 1: Nicole Urbantat, Julia Havenstein  
Team 2: Iris Baumgärtner, Brigitte Gabeli  
Date: 16.-21.02.2007

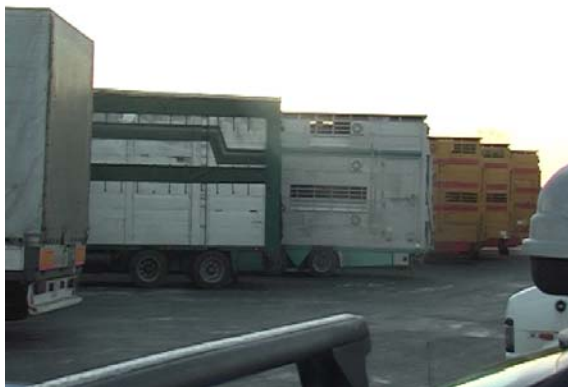
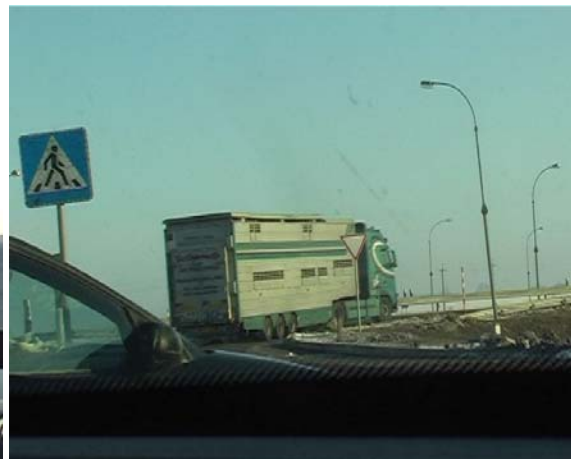
**Animals are not fed or given water at any time during that stop.**

Trucks loaded with cattle (Hefter and Dijkstra) at gas station in BY, Dijkstra truck leaving gas station at 8:08 CET

The cattle were prevalently bellowing during this stop.

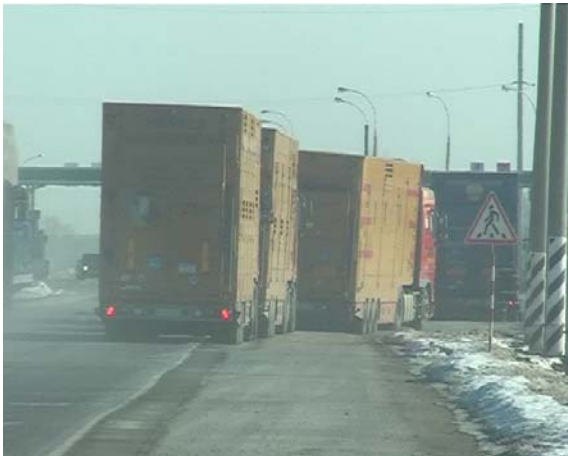
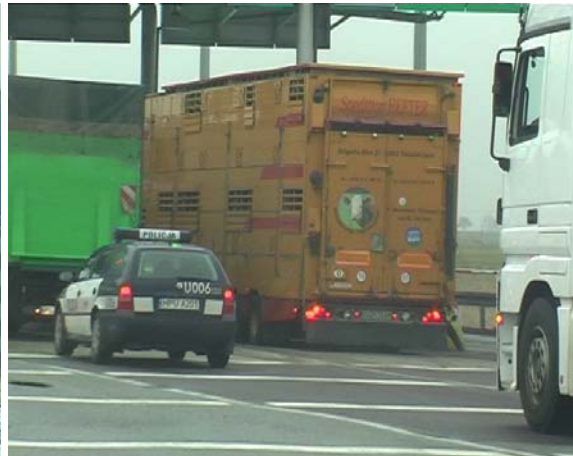
After a **7 hour rest for the drivers**, the 4 trucks continue their journey into direction Minsk. The animals were not given food or water at any time during that stop.

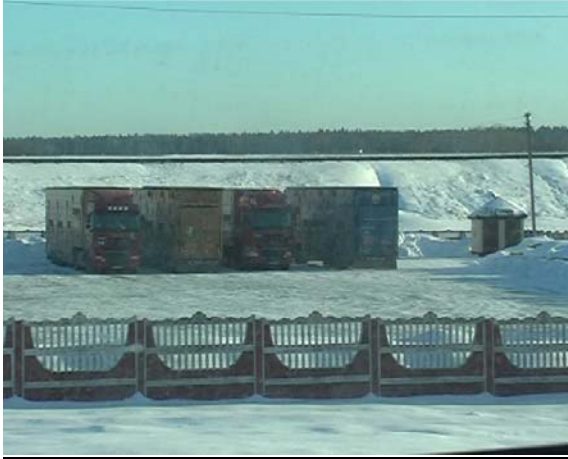
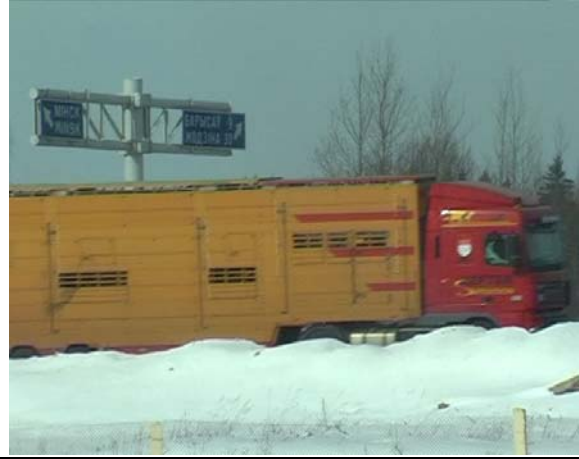
The animals in all 4 trucks are fed with hay, we can not observe they receive water, but we could not observe them all around the clock at this stop.

Hefter trucks parked for 20 hour break at a parking lot: cattle are not unloaded

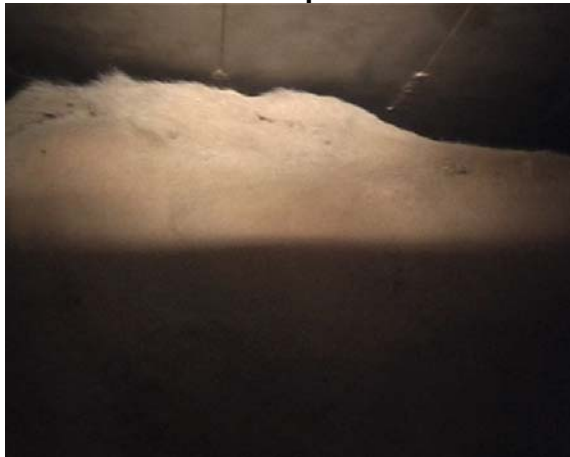
Heifer back almost touching the ceiling
